DEPARTMENT OF TRANSPORTATION

Contract #: 04-0120F4Cty: SF/ALA Rte: 80 PM: 13.2/13.9File #: 69.28**WELDING INSPECTION REPORT****Resident Engineer:** Pursell, Gary**Address:** 333 Burma Road**City:** Oakland, CA 94607**Report No:** WIR-000981**Date Inspected:** 26-Nov-2007**Project Name:** SAS Superstructure**OSM Arrival Time:** 1400**Prime Contractor:** American Bridge/Fluor Enterprises, a JV**OSM Departure Time:** 2330**Contractor:** Zhenhua Port Machinery Company, Ltd (ZPMC), Changxing Island **Location:** Shanghai, China**CWI Name:** Li Zhi Jiang**CWI Present:** Yes No**Inspected CWI report:** Yes No N/A**Rod Oven in Use:** Yes No N/A**Electrode to specification:** Yes No N/A**Weld Procedures Followed:** Yes No N/A**Qualified Welders:** Yes No N/A**Verified Joint Fit-up:** Yes No N/A**Approved Drawings:** Yes No N/A**Approved WPS:** Yes No N/A**Delayed / Cancelled:** Yes No N/A**Bridge No:** 34-0006**Component:** Floor Beams, side & bottom plates for OBG**Summary of Items Observed:**

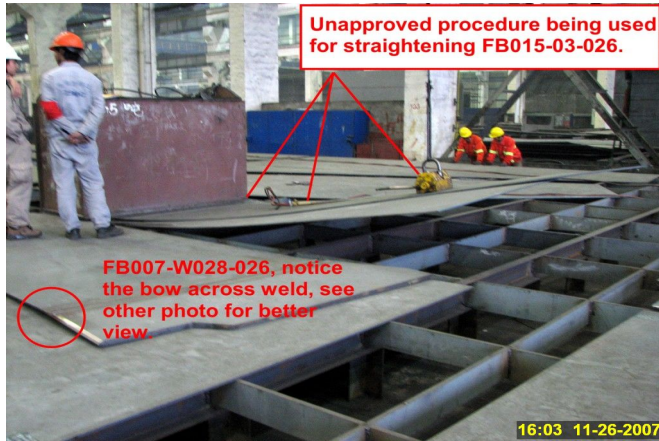
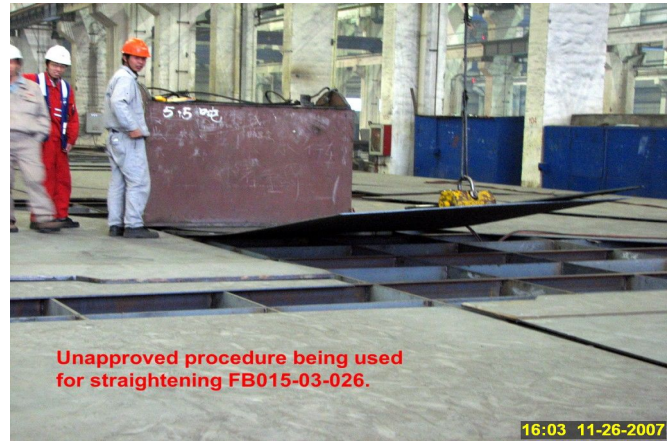
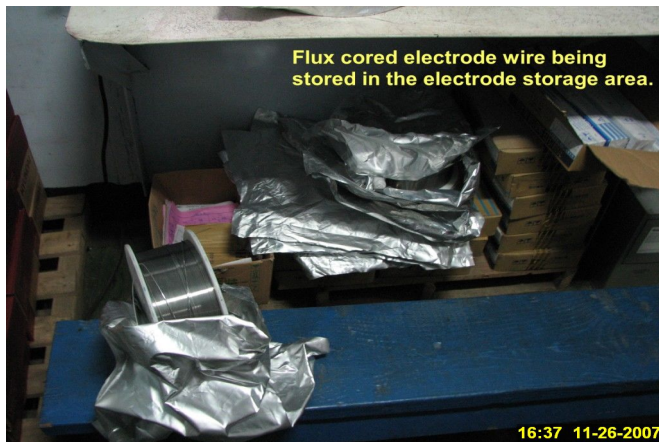
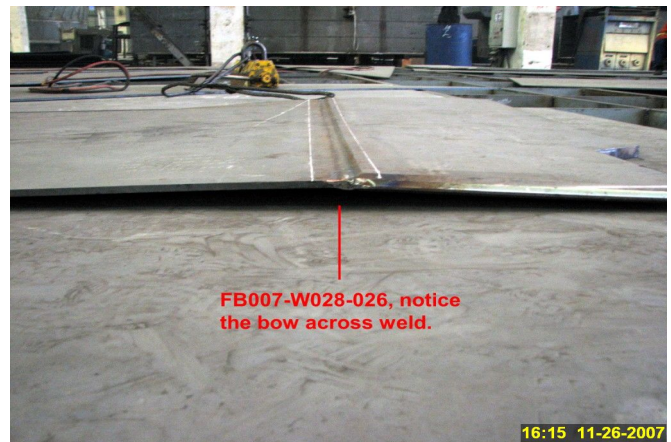
Bay 7: The QA inspector observed heat straightening being conducted on floor beam components #FB015-03, weld 026 & FB007-W028, weld 026. The QA inspector noted that the procedure being used appears to be unapproved by the Engineer. The QA inspector noted that ZPMC Quality Control (QC) person Li Zhi Jiang is monitoring this work. The QA inspector Scott Croff notified the QA inspector Robert Cuellar of these observations. See the attached photos.

As noted above, the QA inspector Scott Croff informed the QA inspector Robert Cuellar of the observed and apparently unapproved heat straightening that was being conducted on the floor beam components. The QA inspector Robert Cuellar was shown the attached photos and remarked that he would notify additional Caltrans personnel regarding any further action on this matter. The QA inspector Scott Croff also informed the QA inspector Robert Cuellar of other observations and conversations as reported above. There were no other notable conversations during this shift.
